The PROCEEDINGS of the  
VERMONT HISTORICAL SOCIETY

Contributors To This Issue	.....	76
Editor's Comment: Vermont's Stone Chambers and the Nature of History	.....	77
Vermont's Stone Chambers: Their Myth and Their History By GIOVANNA NEUDORFER	.....	79
Celtic Place Names in America B.C. By W.F.H. NICHOLAISEN	.....	148
A Vermont Bookshelf: Vermont Books in Review	.....	161

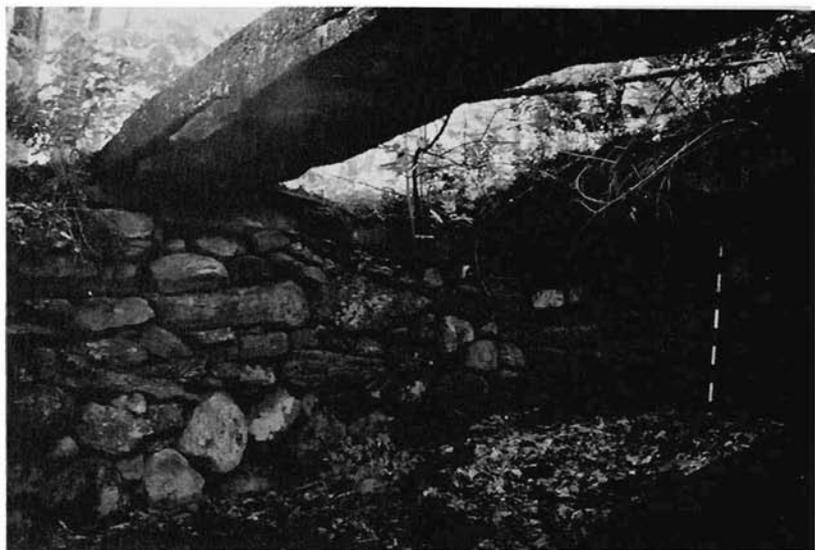
*Chamber No. 26. Collapsed hillside chamber (Type B), Orange County. Note details of ceiling construction and side wall masonry.*

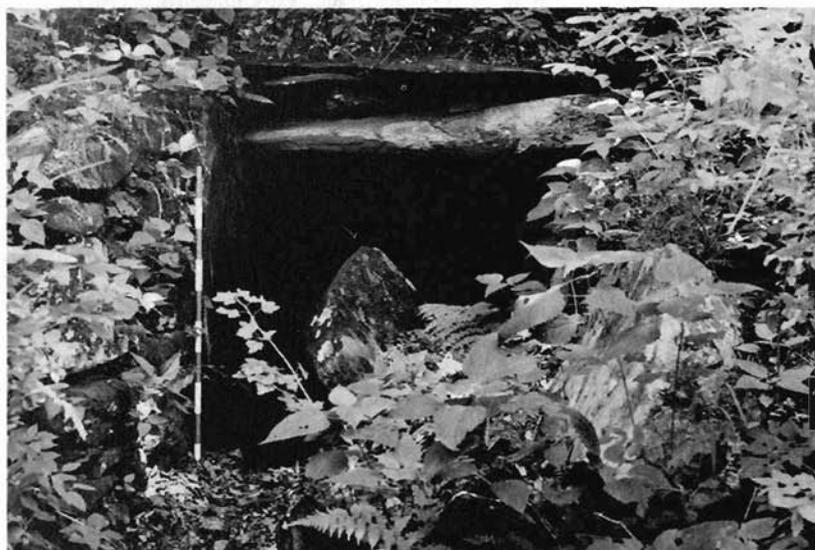
*Chamber No. 14. Hillside chamber (Type B), Windsor County. Note entryway lined with large upright slabs.*

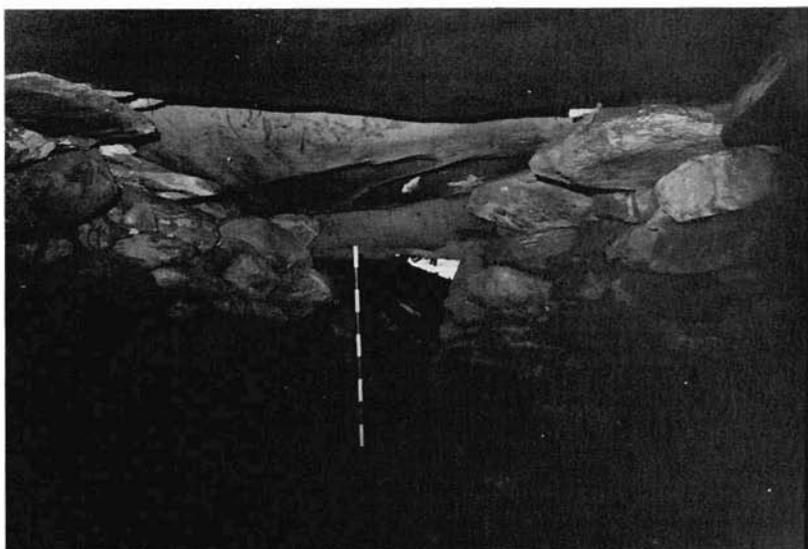
*Chamber No. 29. Hillside chamber (Type B), Windsor County. Ceiling slabs are of Waits River limestone; note details of ceiling construction.*

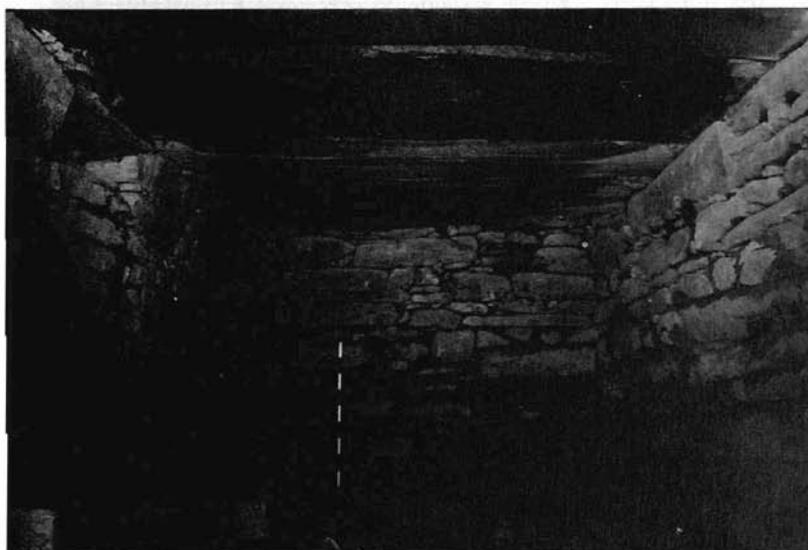
*Chamber No. 11. Chamber built off barn foundation (Type A), Windsor County. Note details of ceiling construction.*

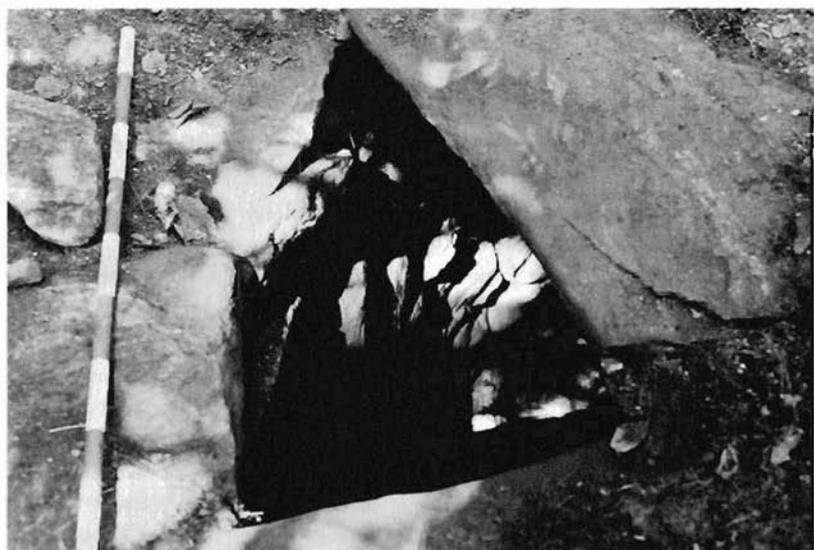
*Chamber No. 3. Close-up of small triangular entryway. From outside looking in.*

The lone exception to the basic ceiling slab type of construction is a unique, semi-round subterranean chamber [No. 3] entered via a small triangular opening at the top of the mound. Rather than being laid parallel to each other and spanning the width of the chamber, the three irregularly shaped ceiling slabs overlap rather intricately to form the triangular entry.

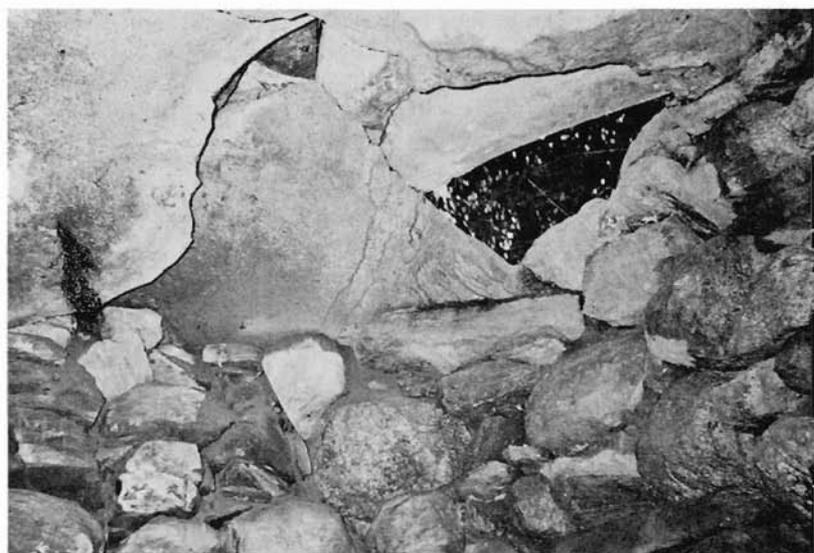
*Chamber No. 3. Triangular entryway, composed of overlapping ceiling slabs. From inside looking out.*

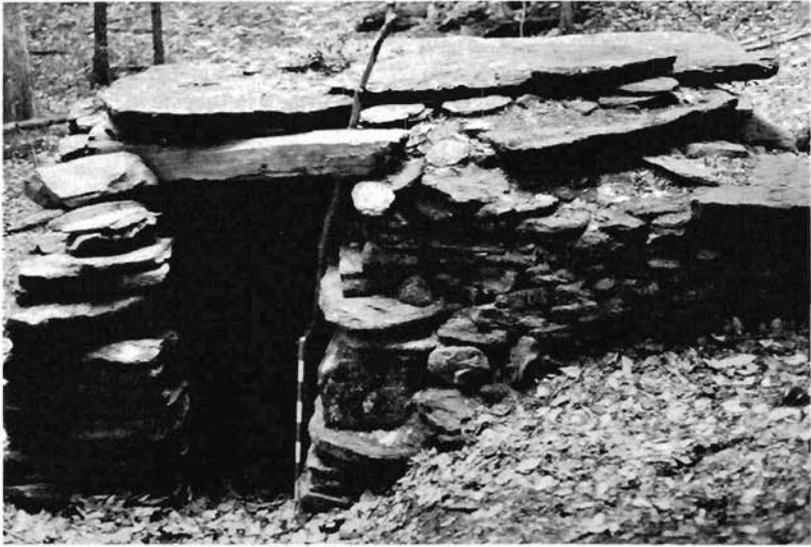
*Chamber No. 17. Freestanding chamber, unrounded (Type B), Windsor County. The only chamber not associated with an abandoned or existing farm complex and locally identified as Oliver Plaisted's hideout.*

nineteenth or early twentieth century sugar house presently situated adjacent to this chamber may have been set upon a pre-existing foundation. Only one chamber in the entire sample [No. 17] stands completely isolated from any buildings or foundation holes, and several lines of evidence indicate that no buildings ever existed near the site. It is also the only chamber at any distance from a roadway, although it is nonetheless accessible by hiking about a quarter mile from an abandoned stage road. In all instances the roadways associated with chambers are old highways or turnpikes many of which are still in use.<sup>78</sup>
