Revisiting the Ethan Allen Homestead: A Closer Look at a Vermont Landmark

Since the Ethan Allen Homestead opened to the public in 1987, there has been a quiet undercurrent of skepticism regarding the building interpreted as the last home of Ethan Allen. Could a reexamination of the building in light of more recent information confirm or debunk the authenticity of this famous relic?

Vermont History 71 (Summer/Fall 2003): 180–196.

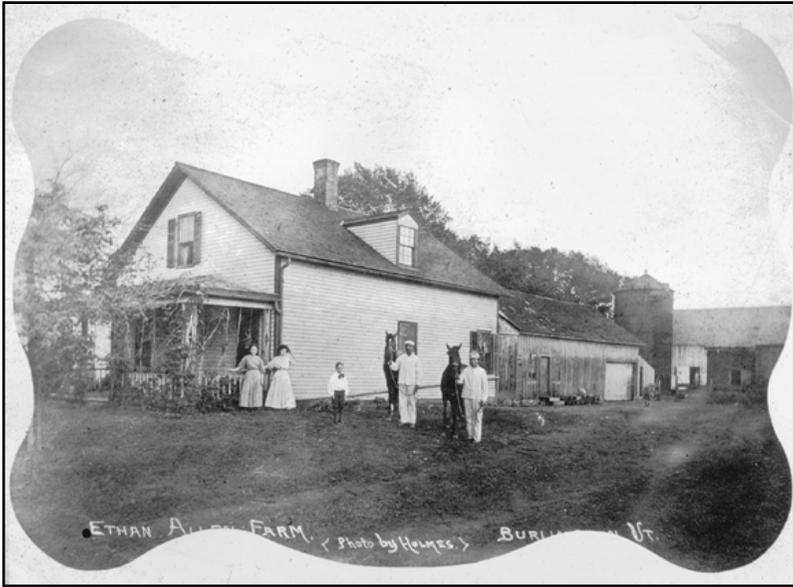
One of the earliest known photographs of the house Ralph Nading Hill identified as Ethan Allen's Burlington home. Taken c. 1905, it shows the mid-nineteenth-century reorientation of the building as a gable-front, Greek Revival cottage. Photograph courtesy of University of Vermont.

Hill’s approach touched lightly on or sidestepped the few kinds of physical evidence generally used to establish a building’s age. Nails securing the sheathing and floorboards to framing timbers were mostly of a type with machine-cut shanks and hand-wrought heads. Completely hand-forged nails were, and by many people still are, considered characteristic of buildings in northwestern Vermont erected prior to c. 1800. Hill cited a nail factory in Fair Haven as the likely source of the cut-shank nails, though the exact dates the factory was in operation were uncertain. Hill never mentioned other potentially telling features: techniques used in cutting and assembling the frame, the overhang of the eaves, and the mixture of mill-sawn and hewn timbers. These and other bits of physical evidence suggested to some observers that the house was built in the first, or even the second quarter of the nineteenth century, not the last quarter of the eighteenth century. The only images of the building prior to its mid-twentieth-century version, a published sketch and privately owned photographs, showed a gable-oriented, Greek Revival-style house.⁸

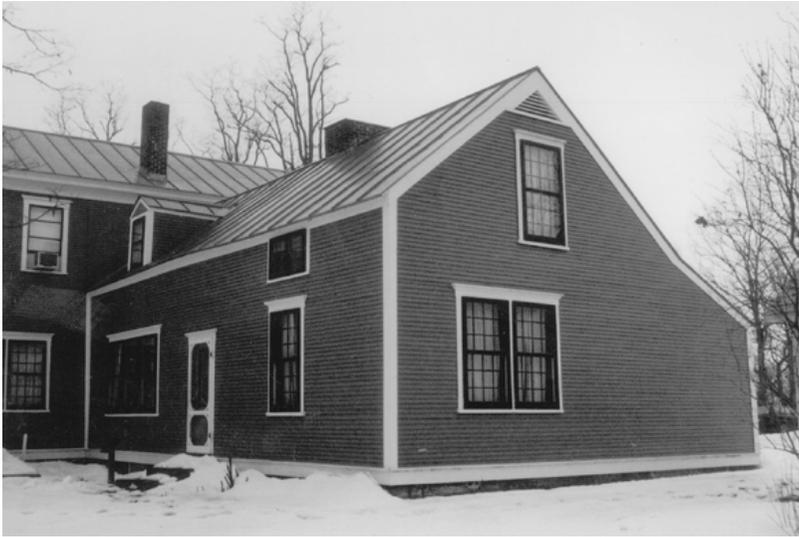
Rokeby, showing the original 1783 house which became the back ell of the main house, added in 1814. Photograph by Steven Mallory

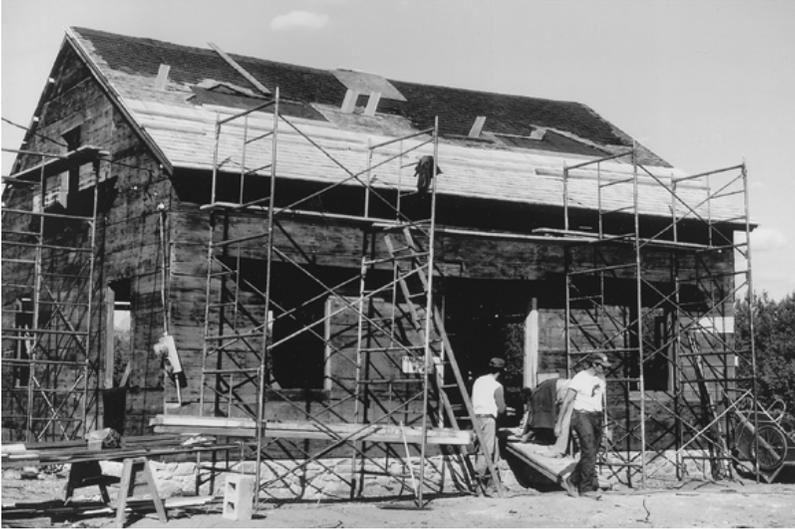
Ethan Allen Homestead after Ralph Nading Hill's crew removed twentieth-century exterior finishes to reveal original sheathing, and had just begun applying wooden roof shingles. The earliest orientation of the building is indicated by door and window openings. Photograph courtesy of Ethan Allen Homestead Trust.
